A case study demonstrating the effectiveness of casting material on a bull

Authors: Niall Connolly, BSc BVSc MRCVS, Lecturer in Livestock Health and Welfare. Philip Leverhulme, Farm Animal Practice, University of Liverpool

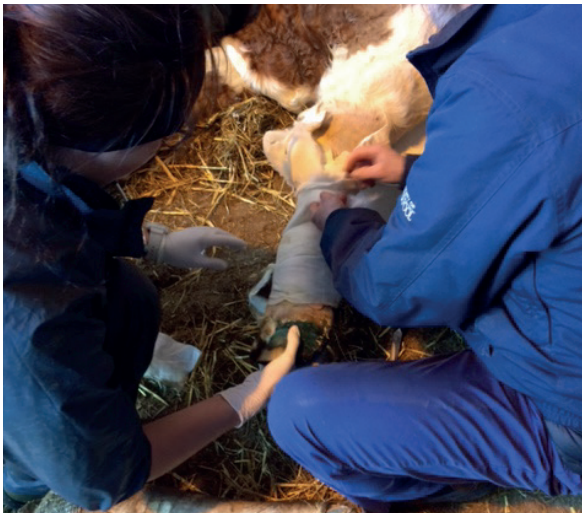
Week four cast change under sedation

The casting material held up against significant strain. The patient used the cast as a lever to get from a sitting to standing position. A cast change was required 4 weeks post-surgery. This was to ensure healing of the surgical wound and allow a tighter fitting cast to be placed, as the initial limb swelling had reduced over time. At 12 weeks post-surgery the cast was removed. The caudal aspect of the cast was able to be preserved and incorporated into a bandage, acting as a splint. This was left in place for a further week to prevent injury to the ligaments and tendons of the lower limb, which had fatigued due to immobilisation.

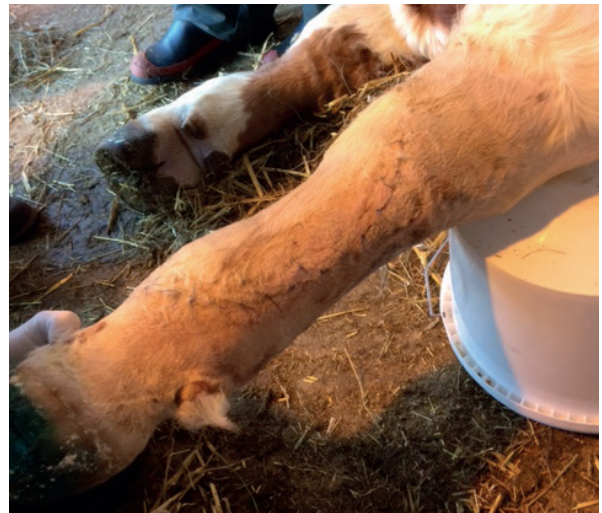
Surgical wound inspection, clean and dry

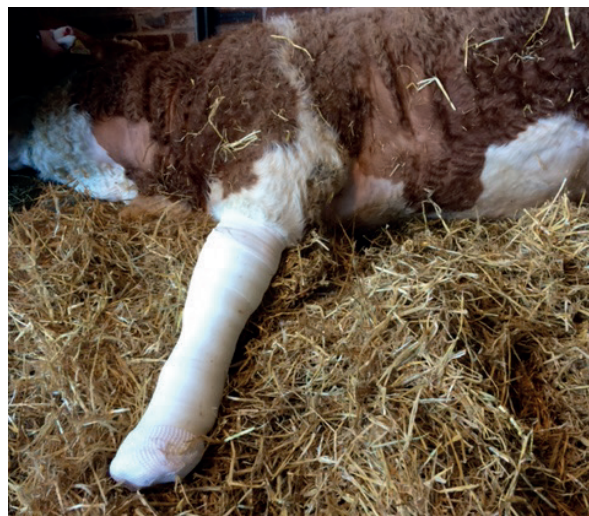
Cast reapplied
